**UNITED STATES DISTRICT COURT
SOUTHERN DISTRICT OF OHIO
WESTERN DIVISION**

KIA MOTORS AMERICA, INC., and
KIA MOTORS CORPORATION,

Case No. 1:15-cv-506

**DECLARATION OF THOMAS READ IN
SUPPORT OF PLAINTIFF'S MOTION
FOR CLASS CERTIFICATION**

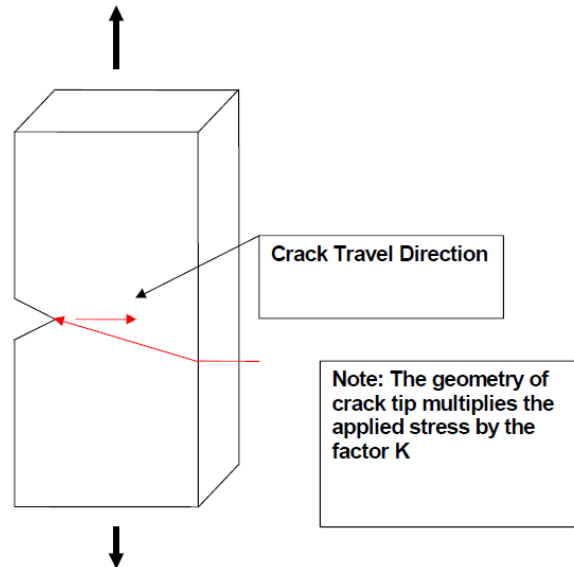
18. Glass only fails in tension as depicted below in Figure #1. Glass can be tempered, which means the outer surfaces of the glass are put into compression. For this reason, thermal temper processes were developed. Thermal tempering is the process of adding surface compression to glass making it stronger.

Figure #1: Illustration demonstrating the only failure mode of glass.

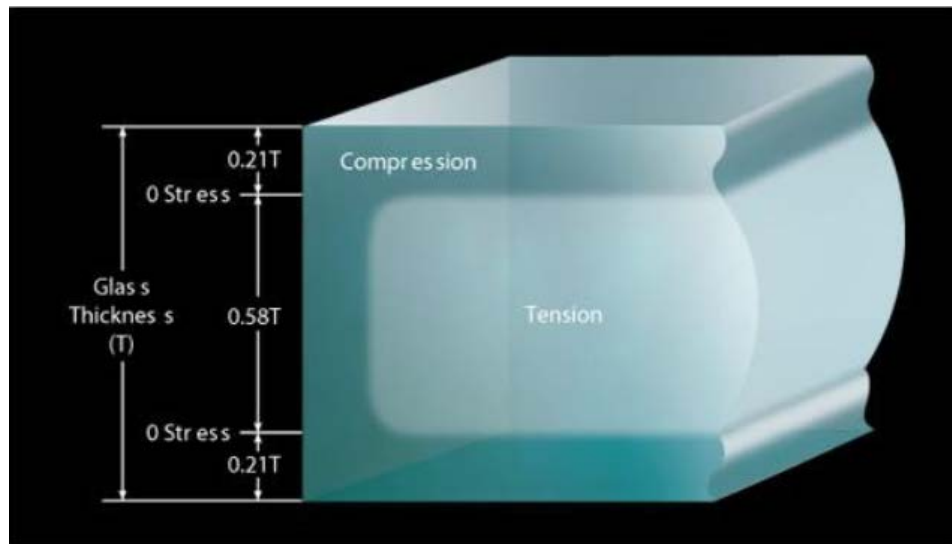
40. Below is the stress profile of tempered glass (See Figures #9 and #10). Approximately, the outer 1/5th of the surface is in compression. The center core is in tension. In order to break this glass by bending, the compressive stresses at the surface must be overcome.

Figure #9: Simplified stress profile of tempered glass.

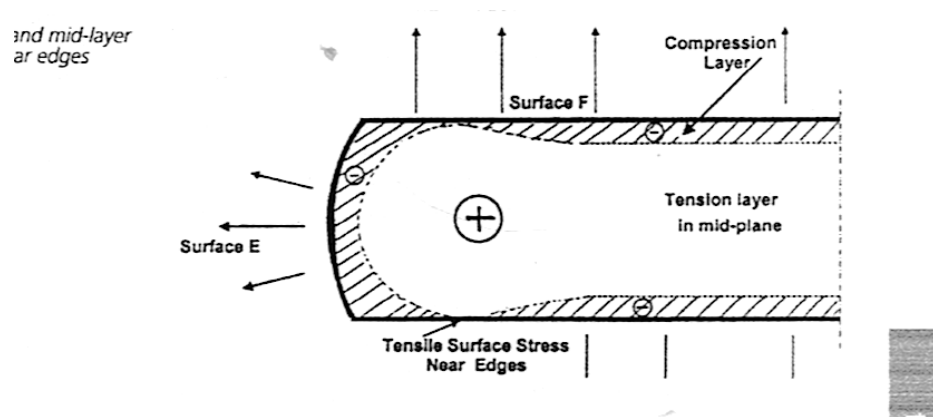
Figure #10: Simplified stress profile of tempered glass near the edge. Because of edge effects the thickness of the protective compression layer is decreased near the edge. Thus, one cannot assume adequate protection from tempering near the edge of the part.

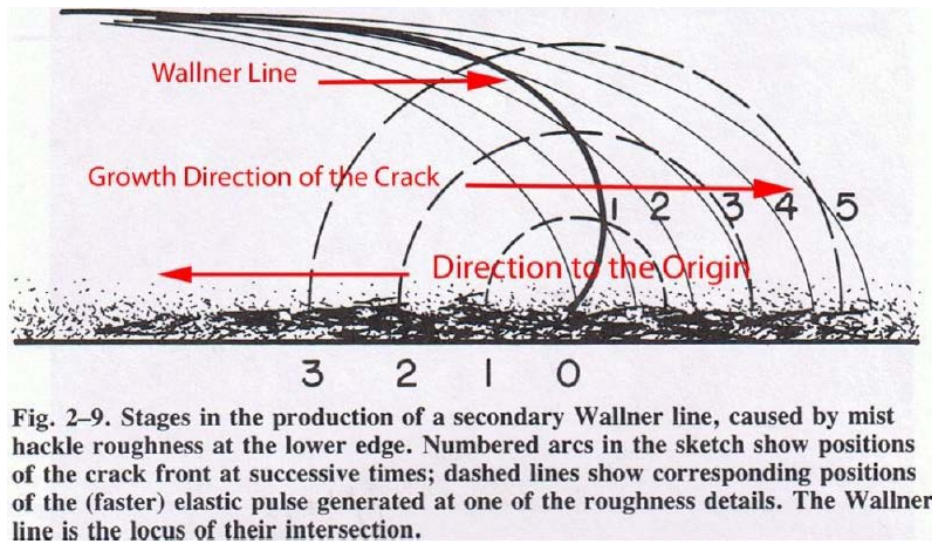
45. Wallner lines are formed as a result of an interaction of the moving crack front with sound waves reflecting off artifacts of the fracture surface. Figure #13 illustrates how one class of Wallner line is formed.

Figure #11: Formation of secondary Wallner lines. In this case the sound waves associated with cracking interact with defects along the edge of the crack. These sound waves reflect back and interact with the crack front and form the Wallner lines. In this case the crack is moving from left to right. One uses the curvature of the Wallner lines to determine the crack travel direction.

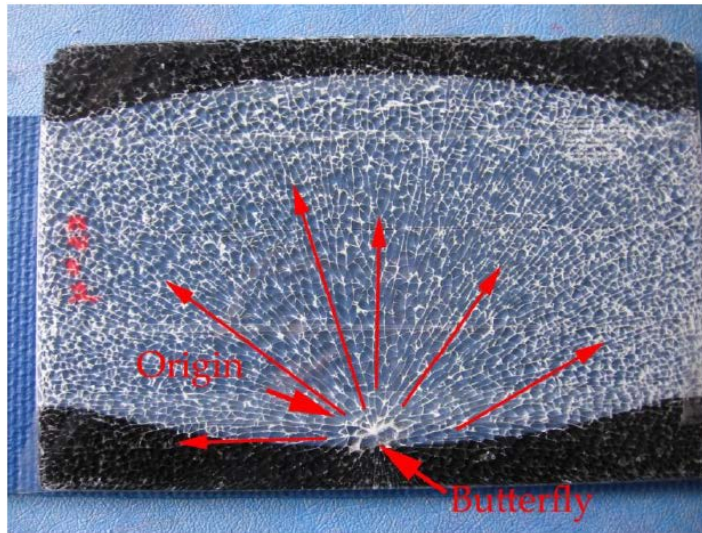
46. Below is a photograph of a tempered soda lime glass toaster oven door that was purposely broken with a spring loaded center punch. This panel was covered with clear tape on the back side, to hold the pieces together, and it was then center punched at the origin. The cracking radiated from the origin, and at the origin is a tell-tale “butterfly”. The failure analysis follows the radiating cracks back to the origin; the pieces at the origin are removed to expose the fracture surface, and the origin is analyzed microscopically to determine the cause.

Figure #12: Demonstration of an overall crack pattern. This is a photograph of a tempered glass toaster oven door panel that was broken using a spring loaded center punch that created a crack that penetrated the compressive layer and caused the glass to self-destruct. The cracking radiates from the origin at a speed of 3600 MPH, and the glass panel breaks into a large number of small pieces.
